National Dam Ins. Prog.
~~DELAWARE RIVER BASIN~~
LONG RUN RESERVOIR NO. 1 DAM
~~LEIGHTON WATER AUTHORITY~~

(NDI NO. PA-00882,
DER NO. 13-004)

CARBON COUNTY, PENNSYLVANIA.
PHASE I INSPECTION REPORT,
NATIONAL DAM INSPECTION PROGRAM

FEBRUARY 1981

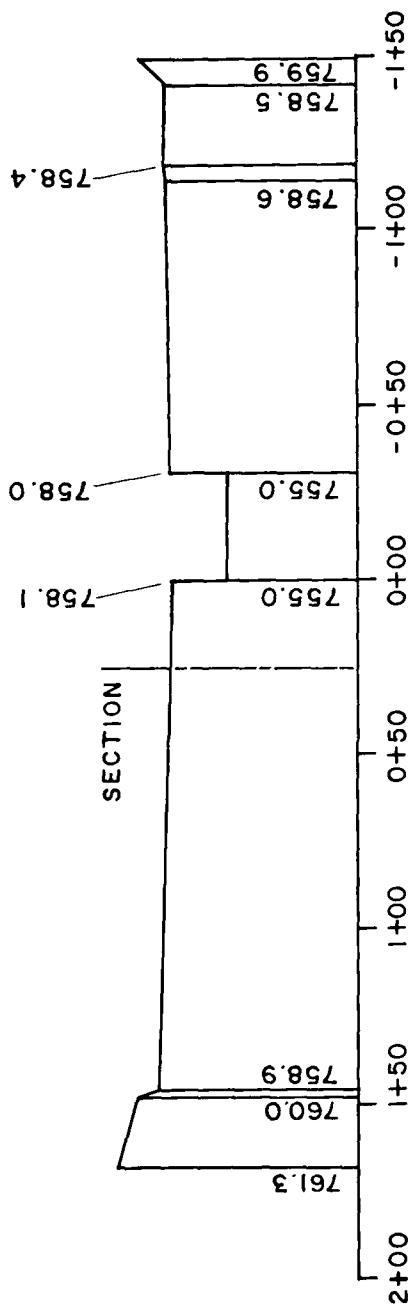
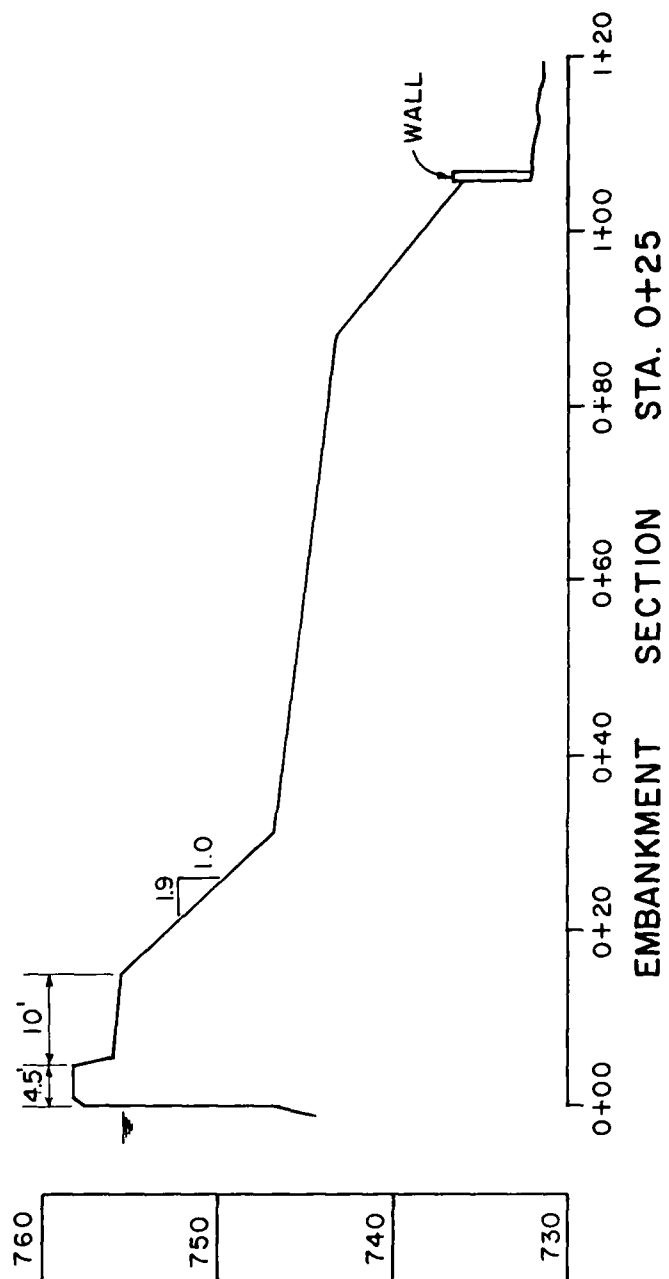
LONG RUN
RESERVOIR No. 1 DAM
PA - 00822
INSPECTION SURVEY
PLATE A-II

The embankment has a wide, sloping berm about 11.5 feet below the top of dam. This berm is 57 feet wide at the location of the section shown on Plate A-II, Appendix A. A masonry wall is located at the toe of the dam behind the valve house. Seepage was noticed through this wall and at the end of the wall. A considerable flow of water was observed seeping from the left hillside downstream from the toe of the fill. It appears that this flow travels from the reservoir, around the left abutment and daylights at the downstream toe. A concrete wall was placed in the reservoir upstream of the dam in an attempt to cut off this flow. This seepage has been reported since the dam was completed in 1911.

C. SLOUGHING OR EROSION OF EMBANKMENT OR ABUTMENT SLOPES	None observed, except footpath on right side of spillway.
D. ALIGNMENT OF CREST: HORIZONTAL: VERTICAL:	Downstream embankment section appears uniform. Refer to profile for vertical data (Plate A-II).
